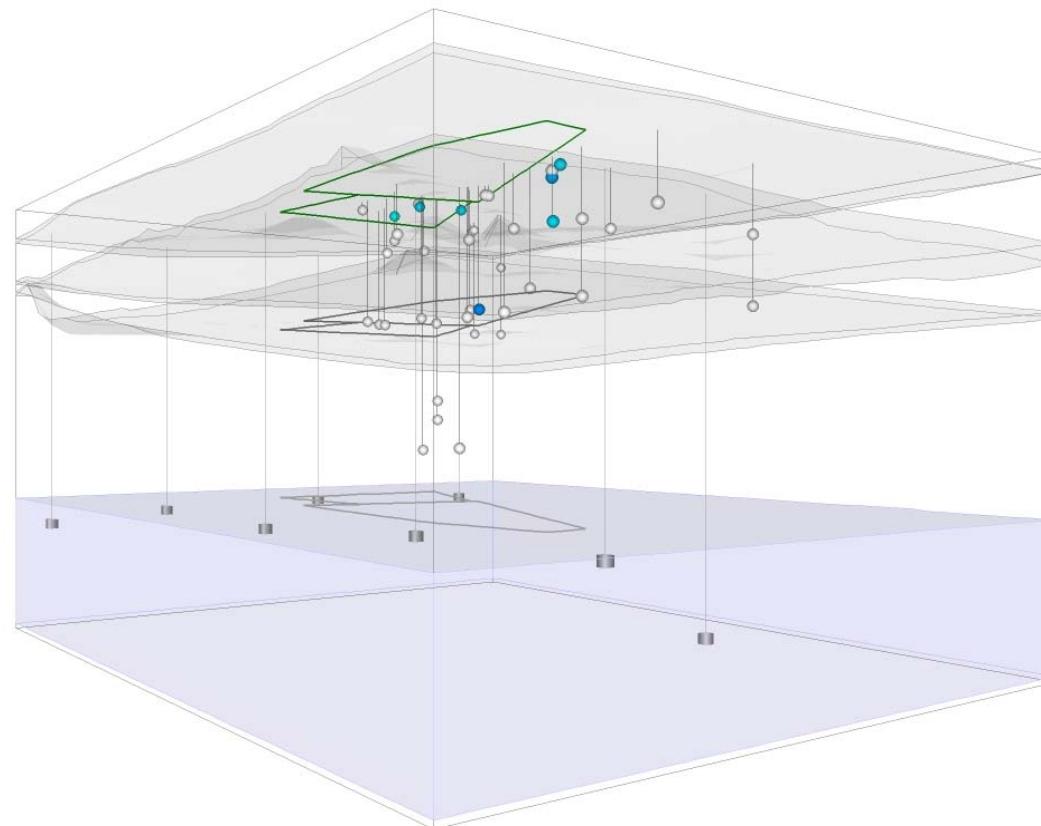
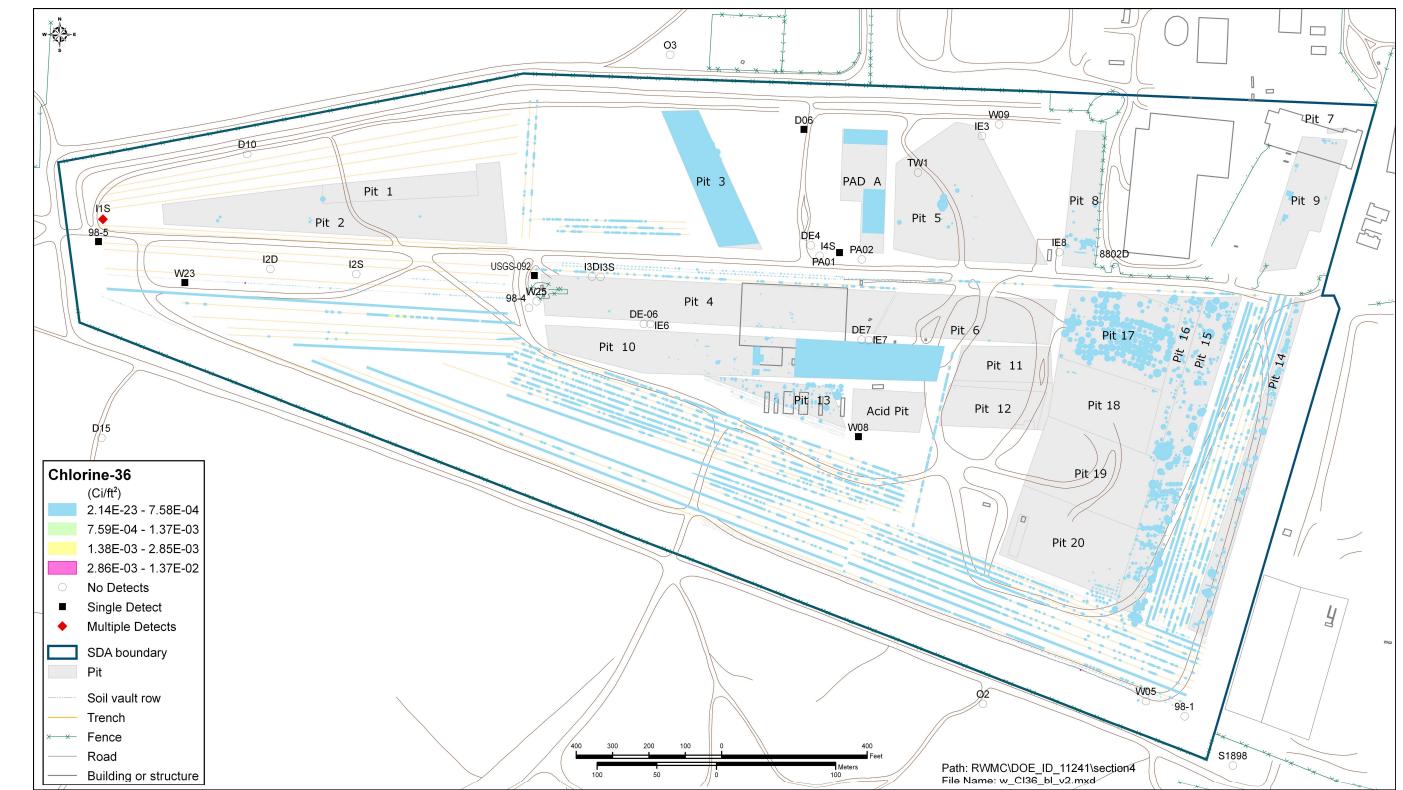
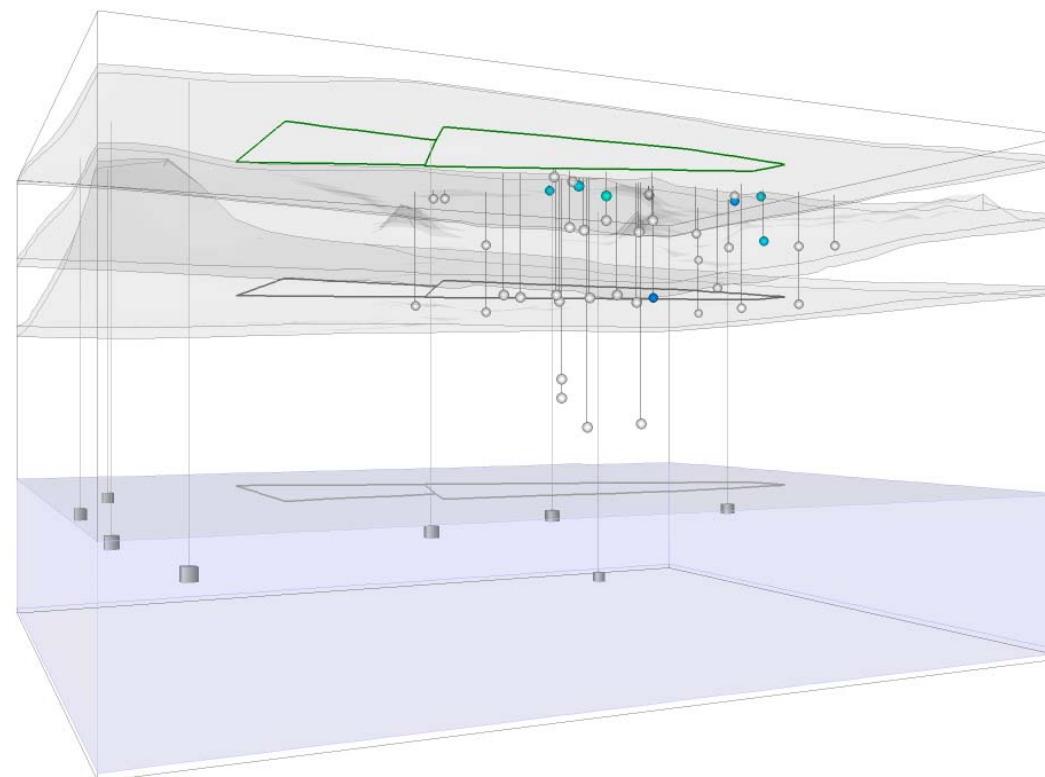
Figure 4-97. Plan view and three-dimensional view of chlorine-36 detections in vadose zone core, lysimeters, and the aquifer.

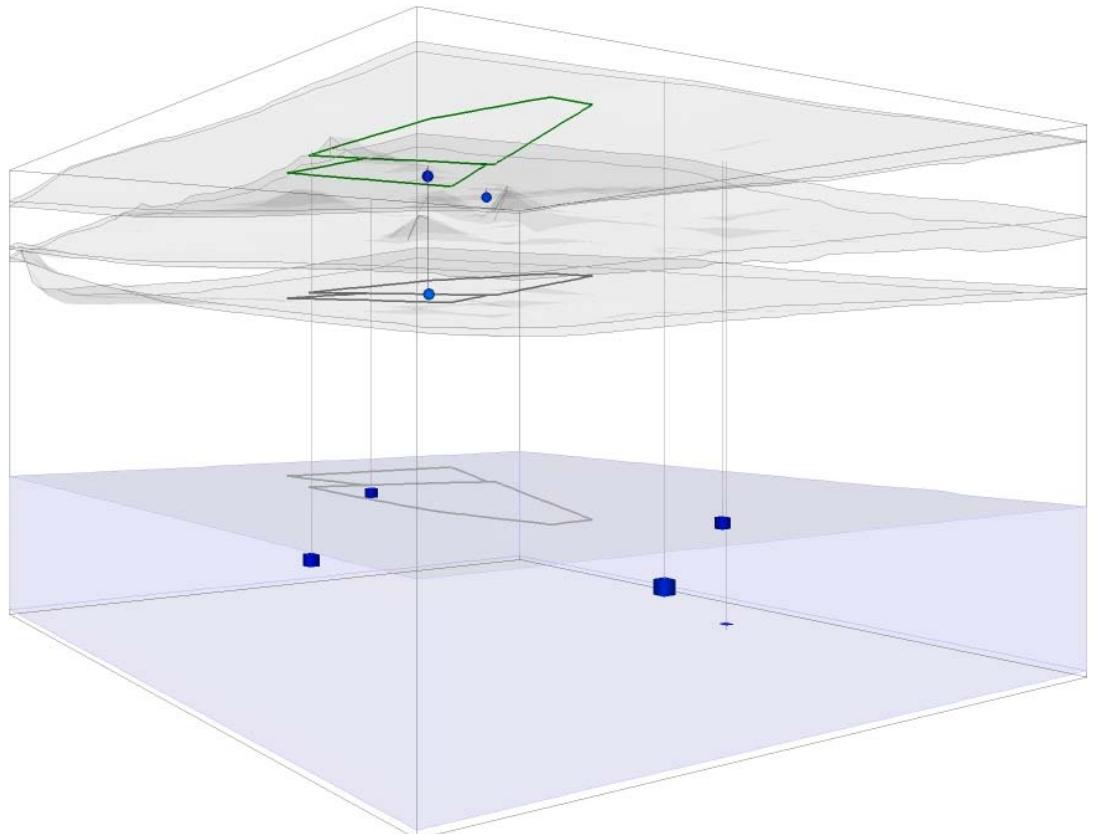
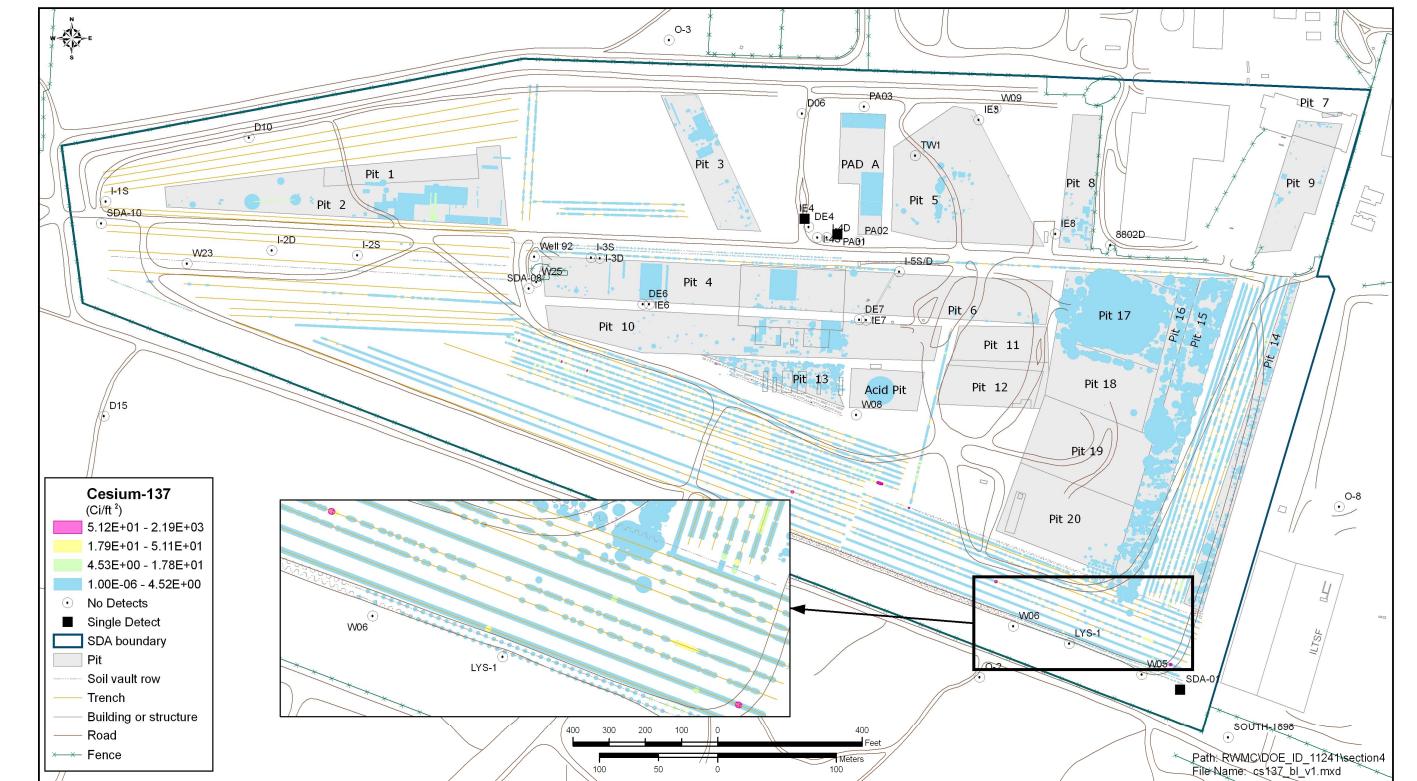
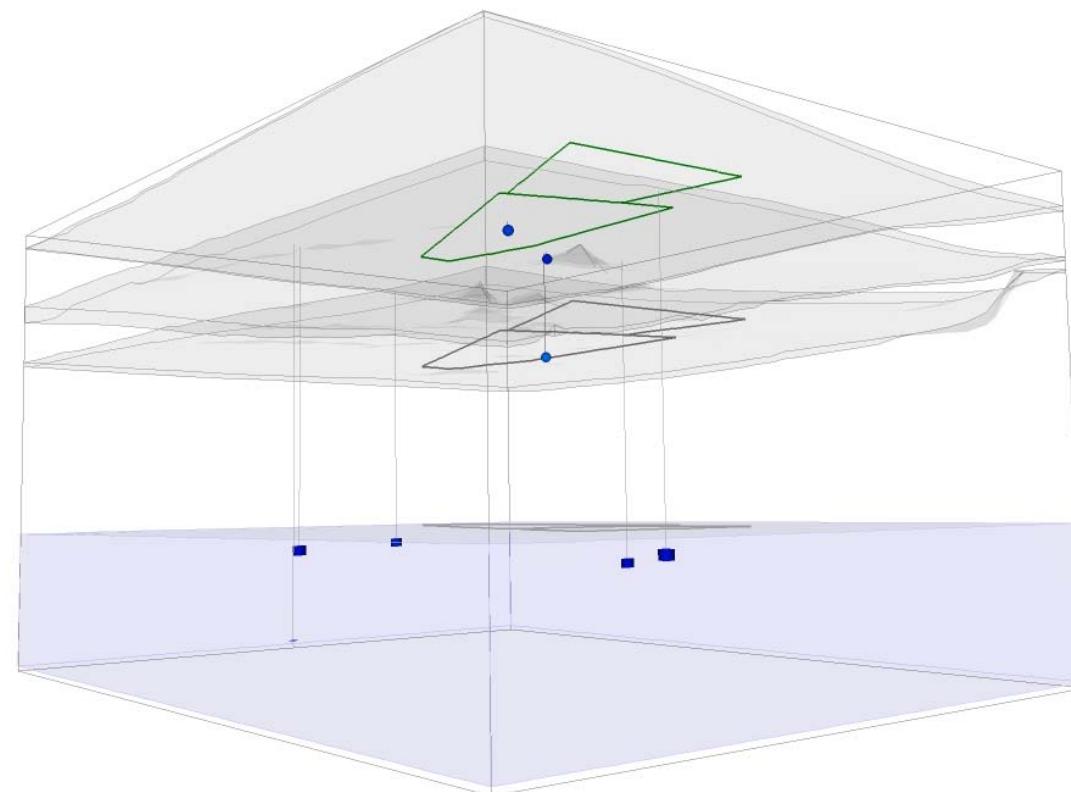
Figure 4-98. Plan view and three-dimensional view of cesium-137 detections in vadose zone core, lysimeters, and the aquifer.

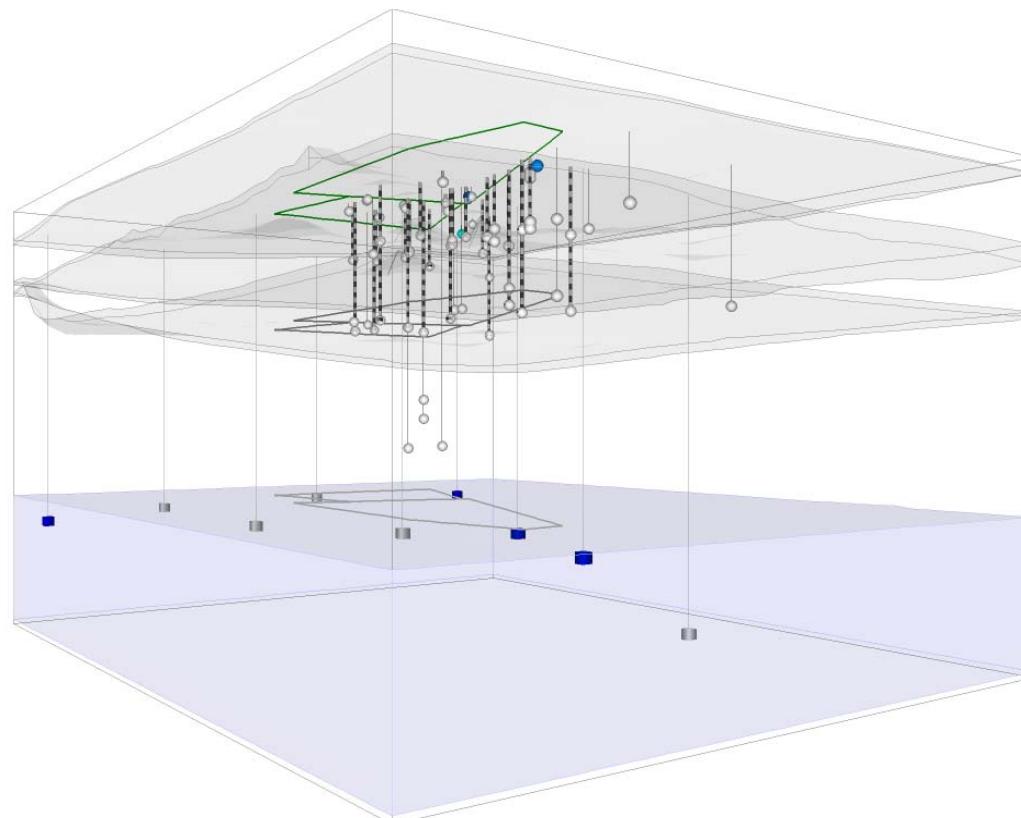
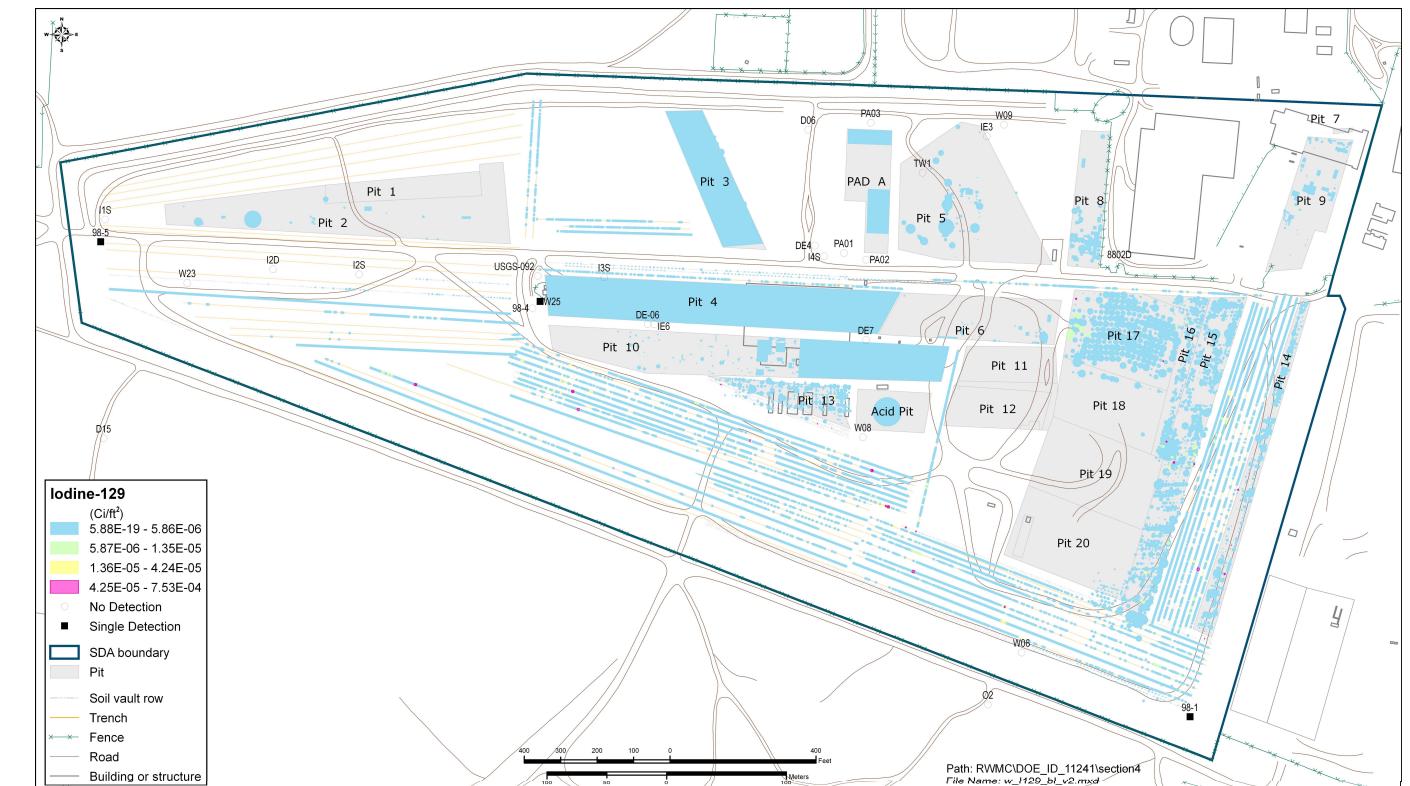
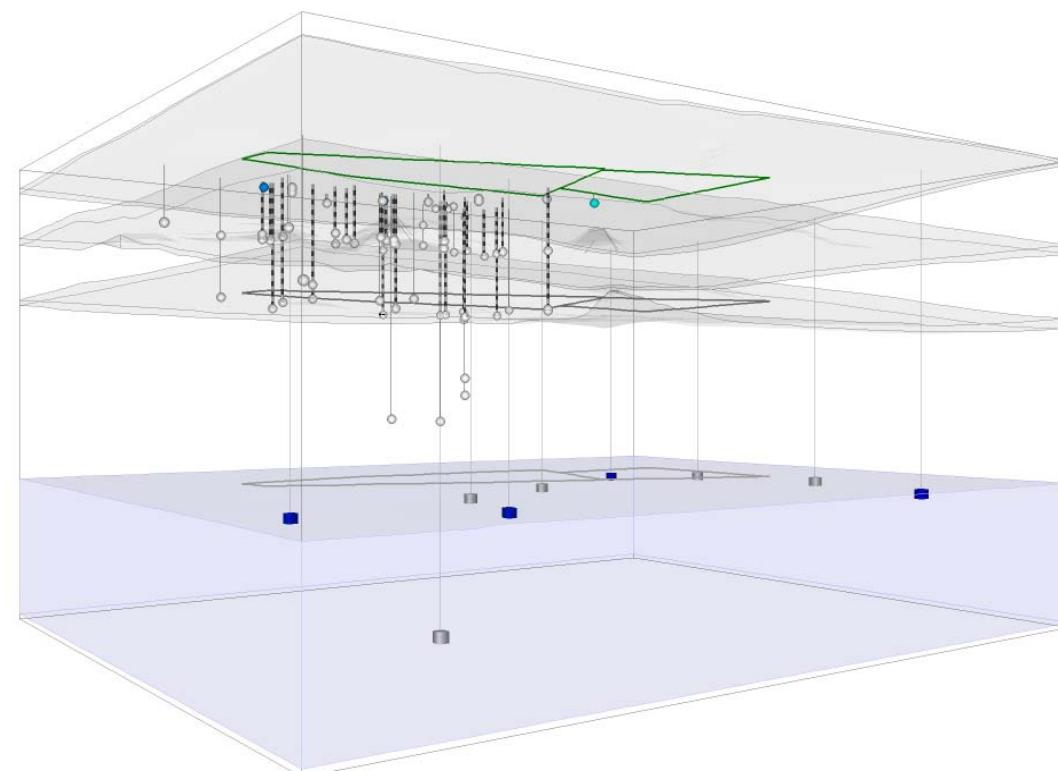
Figure 4-99. Plan view and three-dimensional views of iodine-129 detections in vadose zone core, lysimeters, and the aquifer.
